# Ala Moana Shopping Center Parking Garage Beam Repair

## Beam Repair - 1997

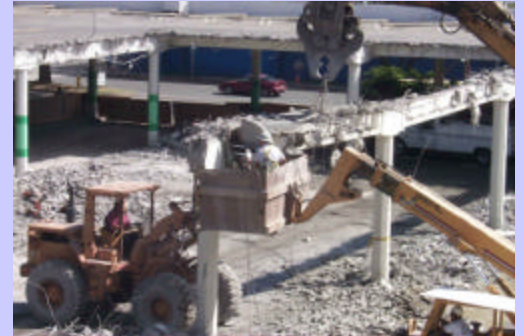
Beam Recovery for Testing

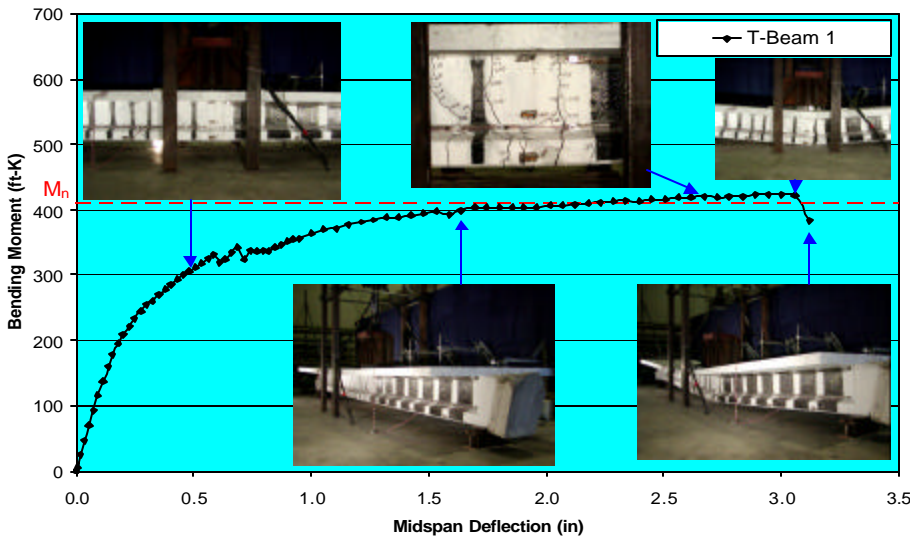
## Moment Capacity

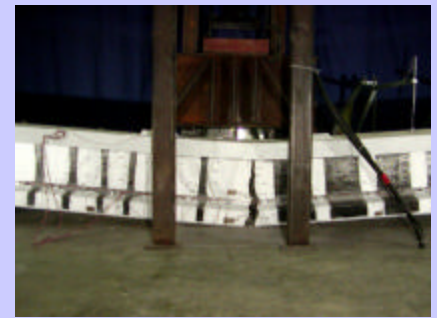
## Control Specimen Flexural Test

T-Beam 1 Failure

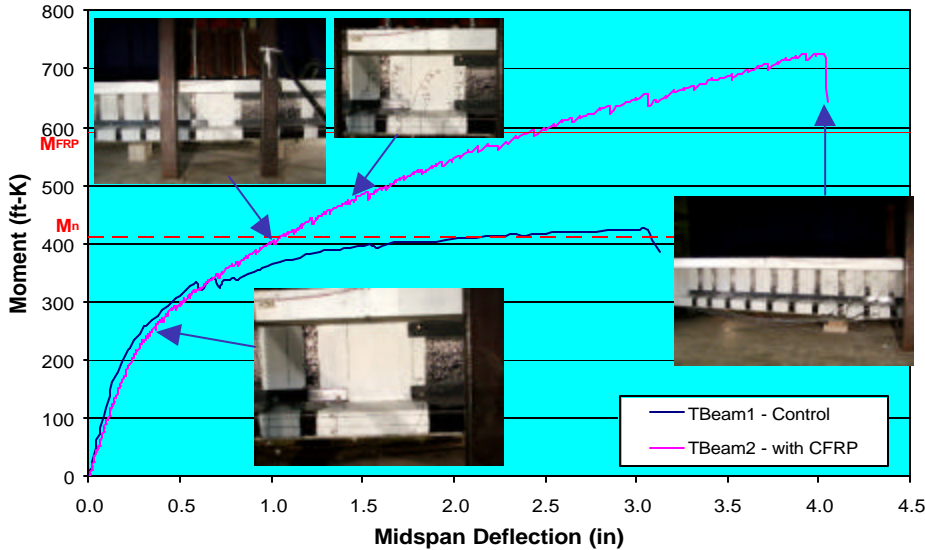
## Moment Capacity

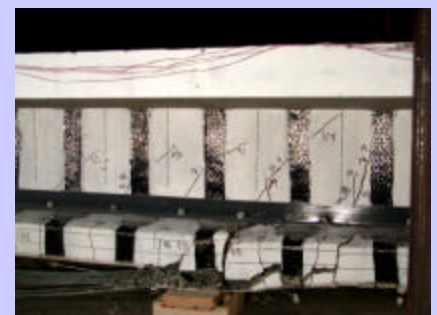
## CFRP Strengthened Specimen Test

T-Beam 2 Failure
